ALLOTMENT 313 IN D7820  
464 SALISBURY HIGHWAY

## Pre-development Arboricultural Impact Assessment

S24496

464 Salisbury Highway  
Parafield Gardens SA

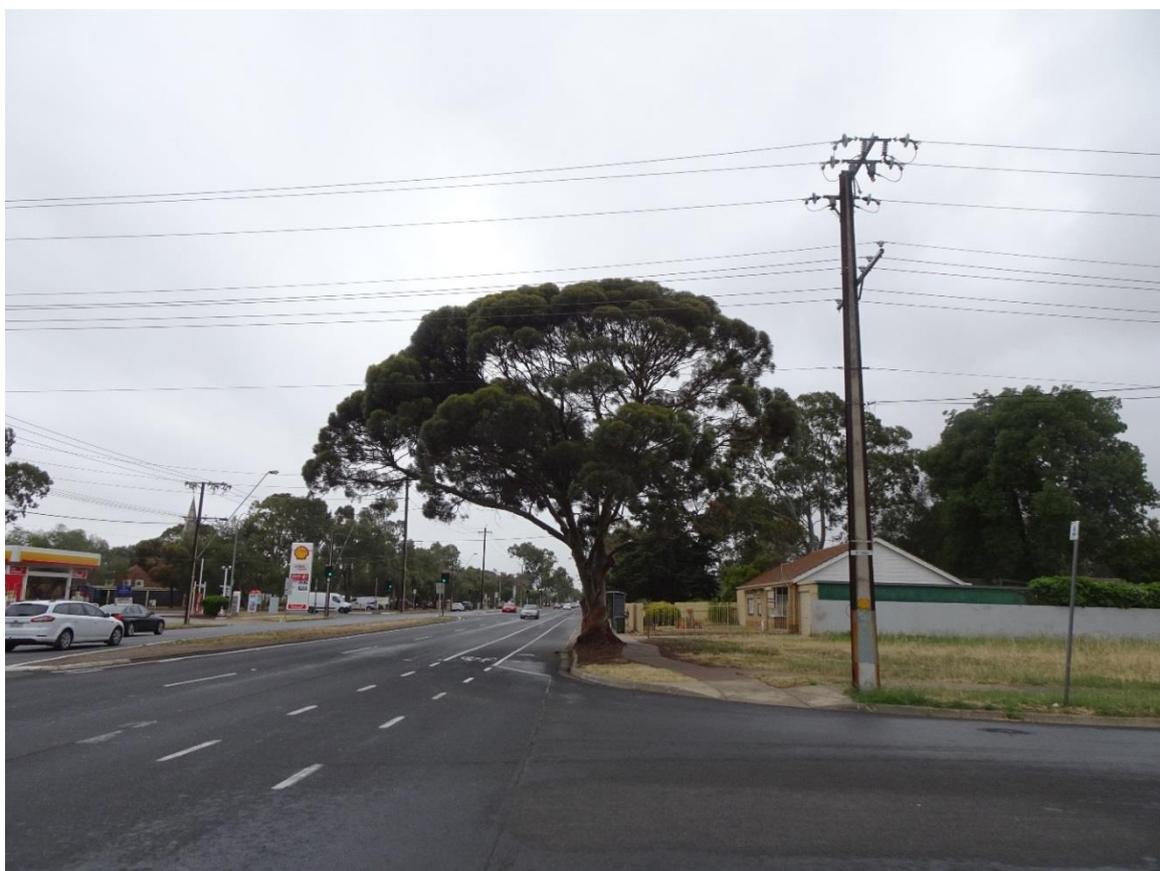
Subject tree viewed from south.

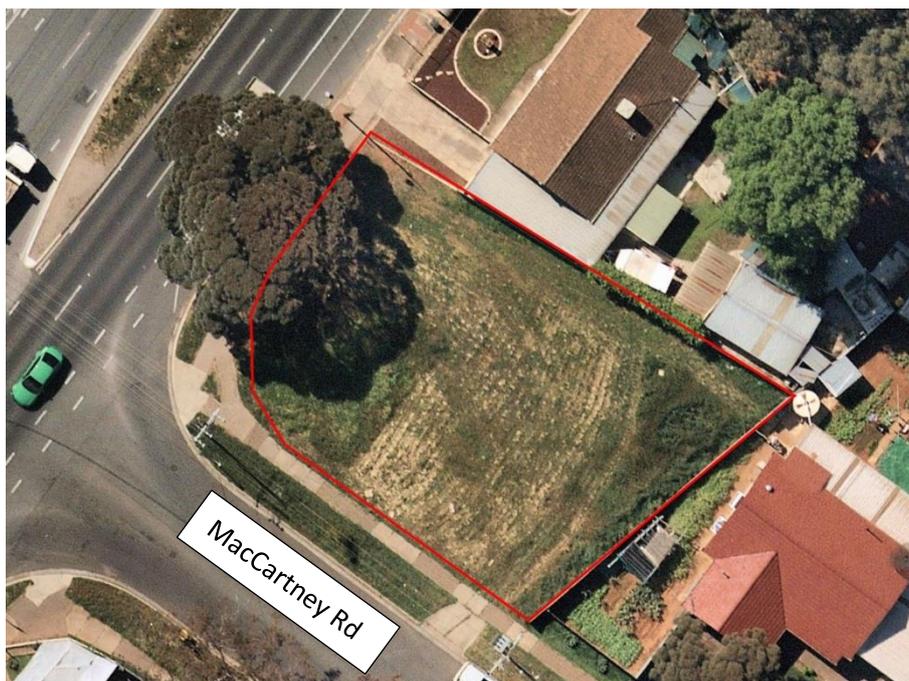
Figure 1: Aerial view showing development site and subject tree.

The site comprises a residential allotment at the corner of Salisbury Highway and MacCartney Road (refer **Figure 1**). The site is currently vacant but historic imagery indicates that a dwelling was formerly located on the site, and was demolished sometime between Nov 2015 and Jan 2016 (refer **Figure 2**). It is understood that the dwelling may have been subject to a house fire. The subject tree is located on the Salisbury Highway verge adjacent to a brick-paved footpath.

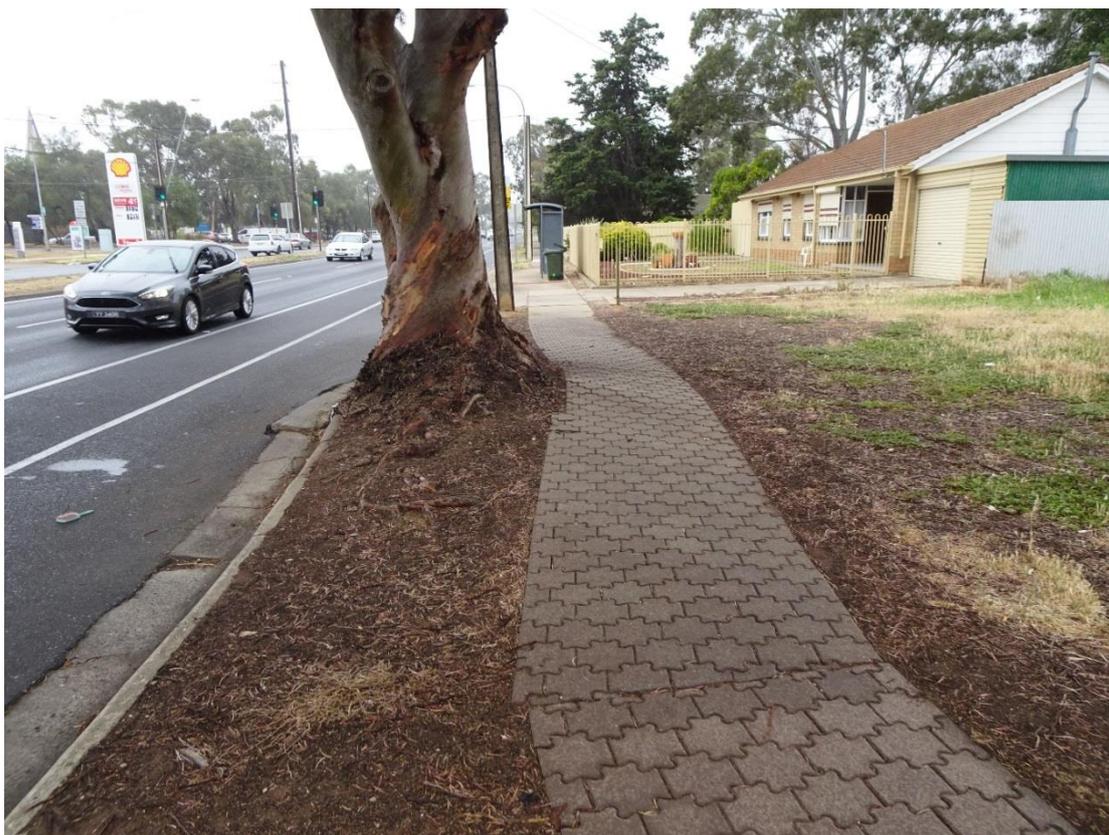
The subject tree is *Eucalyptus spathulata* (Swamp Mallet) which is endemic to Western Australia but not to South Australia. It has a multi-stemmed, mallet habit with a spreading canopy, smooth bark and narrow leaves. The species is widely cultivated in southern Australia and can be grown on range of sites, including heavy soils affected by high levels of salinity, seasonally waterlogged areas and on sandy alkaline soils derived from limestone. The species is not widely planted now for a number of reasons which have emerged as trees planted in the 1980s have matured. The growth habit may include shallow roots when grown on clay soils which may out-compete adjacent plants. The tree is located in the street verge as follows:

- In a 1.3m wide open verge between the street kerb and paved footpath.
- Approx. 8.5m from the northern site boundary.

Photo showing tree base and growing environment.

The trunk circumference measures 3.15m at 1 metre above natural ground level therefore it is deemed to be a 'significant tree' when assessed against the South Australian Development Act 1993. The tree is also a Council-owned asset.

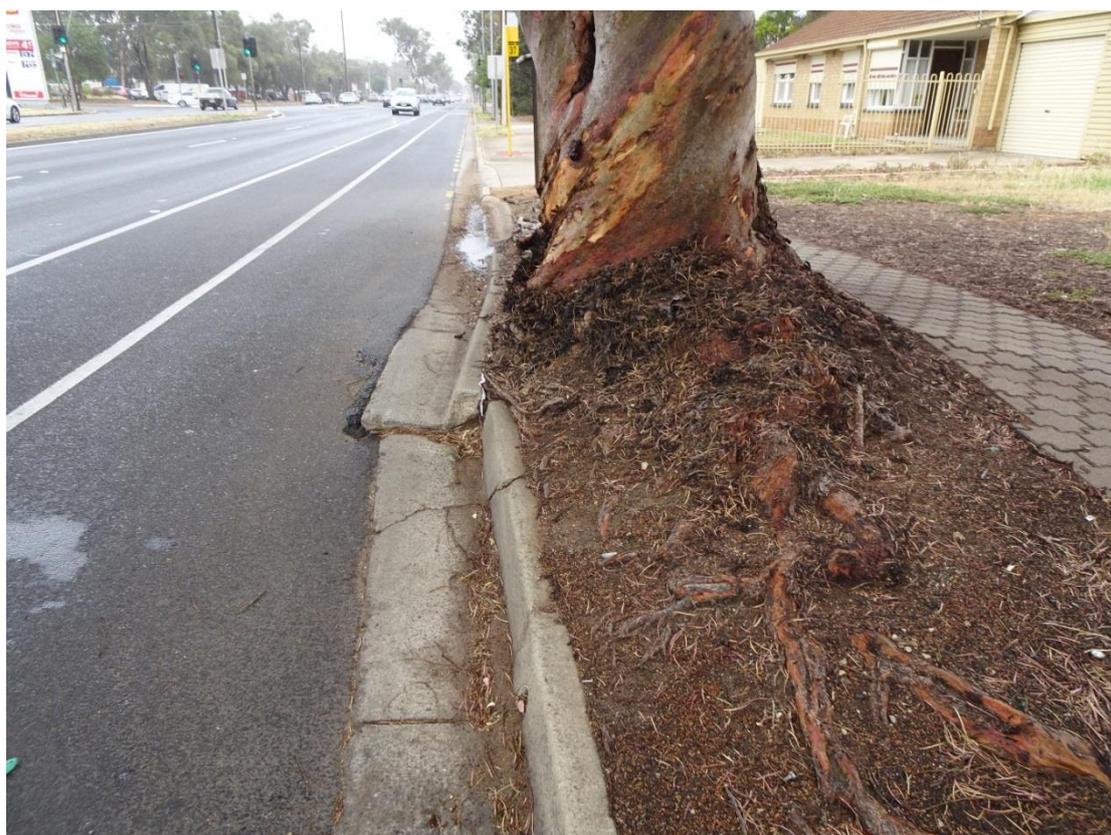
The tree exhibits good health and vigour, and average structure with a spreading crown biased to the west over Salisbury Highway. The tree has a pronounced basal flare and root buttressing with large exposed surface roots disrupting the kerb and brick paved footpath. This is typical of older specimens of the species.

**Photo showing exposed surface roots and disruption of adjacent infrastructure.**

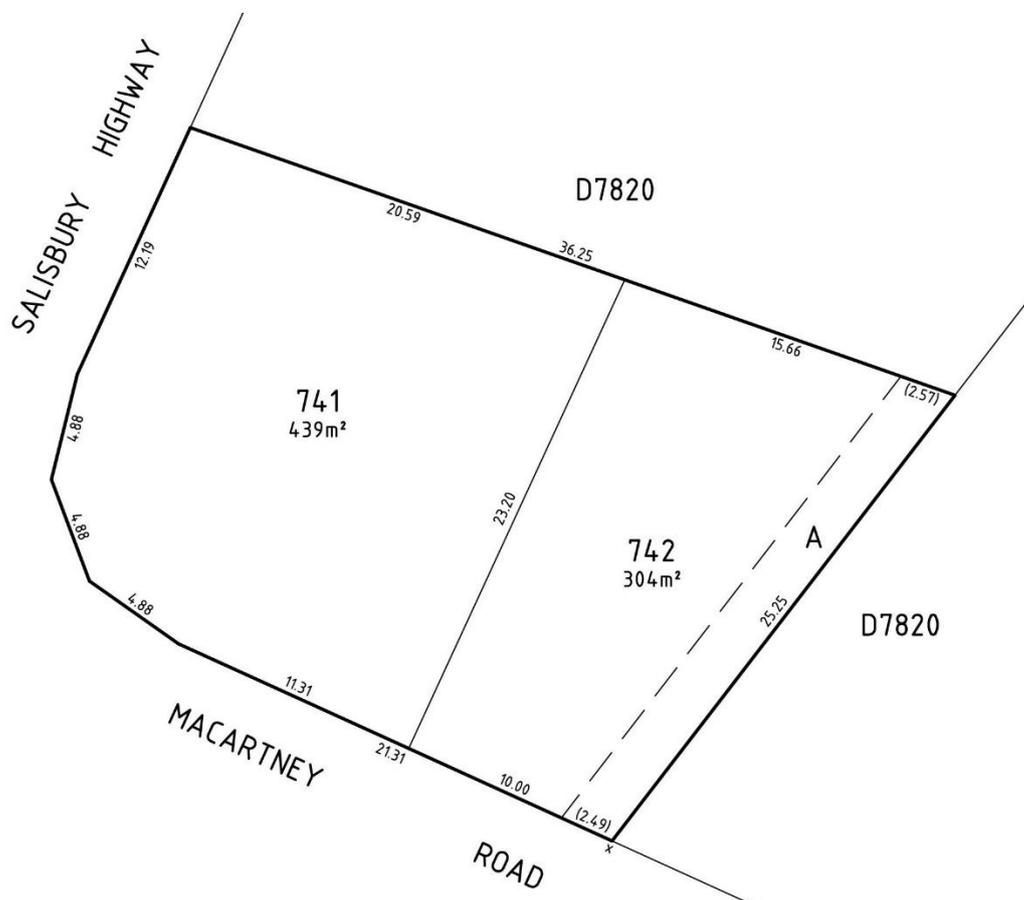
The proposed development includes division of the land into two new allotments (**refer plan below**). The plans do not indicate building footprints, driveway locations or new service connections. The larger allotment 741 can provide some placement options.

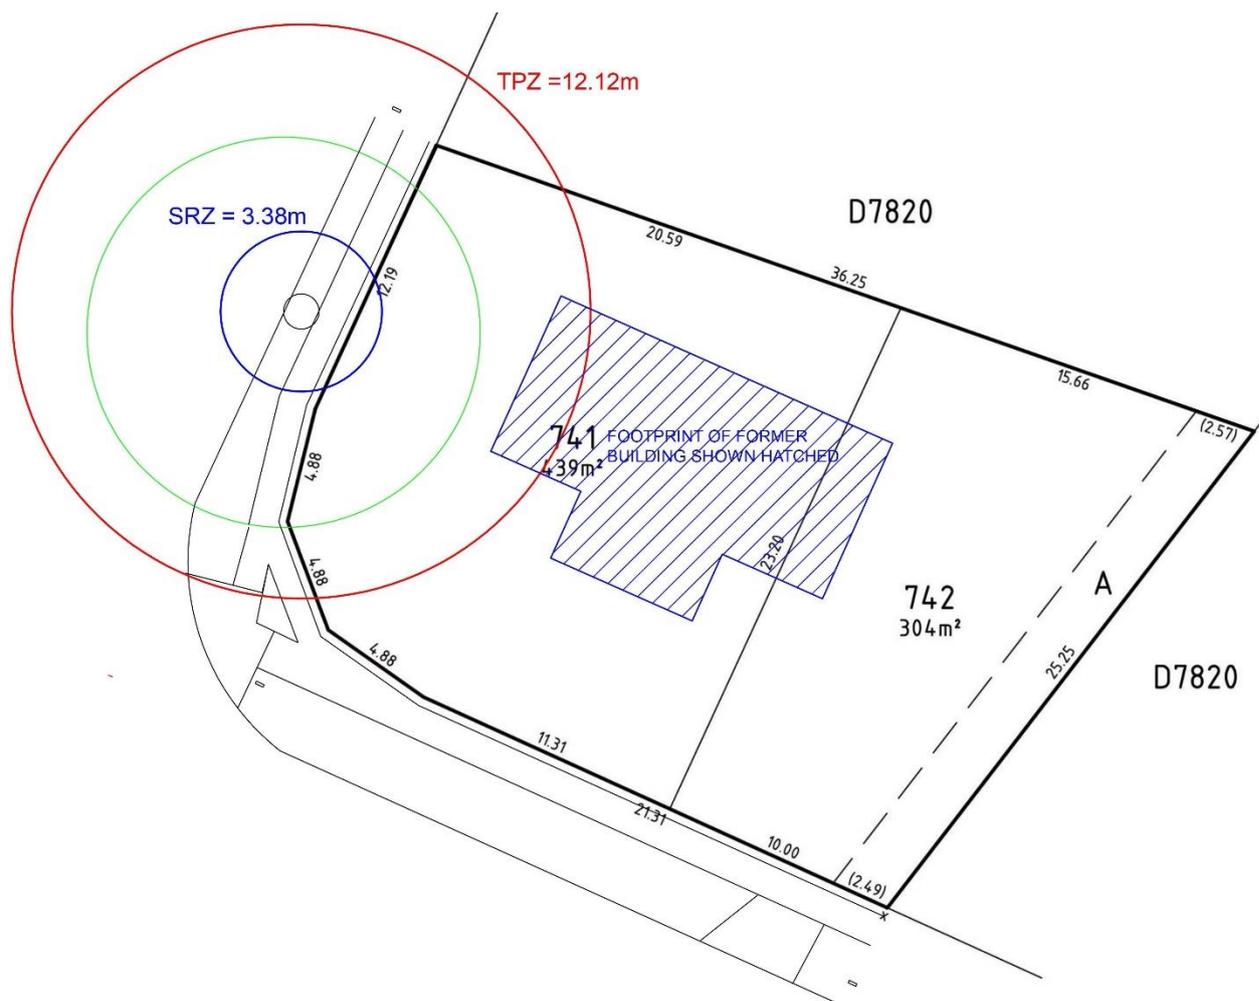
Figure 3: TPZ Plan (TPZ [red], SRZ [blue], approximation of crown [green]).

Tree species	<i>Eucalyptus spathulata</i>
DBH (mm)	1010
TPZ (radius m)	12.12
TPZ (area m <sup>2</sup> )	461
Diam. at base (m)	1050
SRZ (radius m)	3.38

The TPZ occupies approx. **152m<sup>2</sup> or 34%** of Lot 741 providing some constraints on site development (refer Figure 3).

Consideration is also given to the presence of any pre-existing structures within the TPZ. The existing roadway occupies an area of approximately **205m<sup>2</sup> (44%)** of the TPZ. This has been established for a long period of time at it is likely that the tree would have adapted to its presence.

The former dwelling occupied an area of approximately **15.0m<sup>2</sup> (3.2%)** of the TPZ. Tree roots are unlikely to have colonized the area under the former building footprint. Any new building work on the former building footprint would not be considered as a new encroachment.

As a general guideline, site development should aim for a maximum 10% TPZ encroachment for the tree (this includes site works and services as well as building footprints).

No excavation is permitted within the SRZ of a tree.

- The new dwelling on Lot 471 should be set back from Salisbury Highway frontage at the setback of the former dwelling if possible, to avoid encroaching into the TPZ.
- Some building encroachment is allowed within the 10% guidelines. Any new building work on the former building footprint would not be considered as a new encroachment.

- The new crossover to Lot 471 should be located on MacCartney Street near the eastern site boundary, outside the TPZ of the tree.
- The new driveway at Lot 471 should be located outside the TPZ of the tree. Any driveway within the TPZ should comprise an approved permeable paving system or open jointed pavers.

- New underground services will be required to service the new dwelling at Lot 471.
- These should be located outside the TPZ if possible (i.e. on MacCartney Street).
- If underground services cannot be routed outside of the TPZ, they should be installed using 'soft dig' methods such as hydro-excavation or direction boring under guidance of the project arborist.

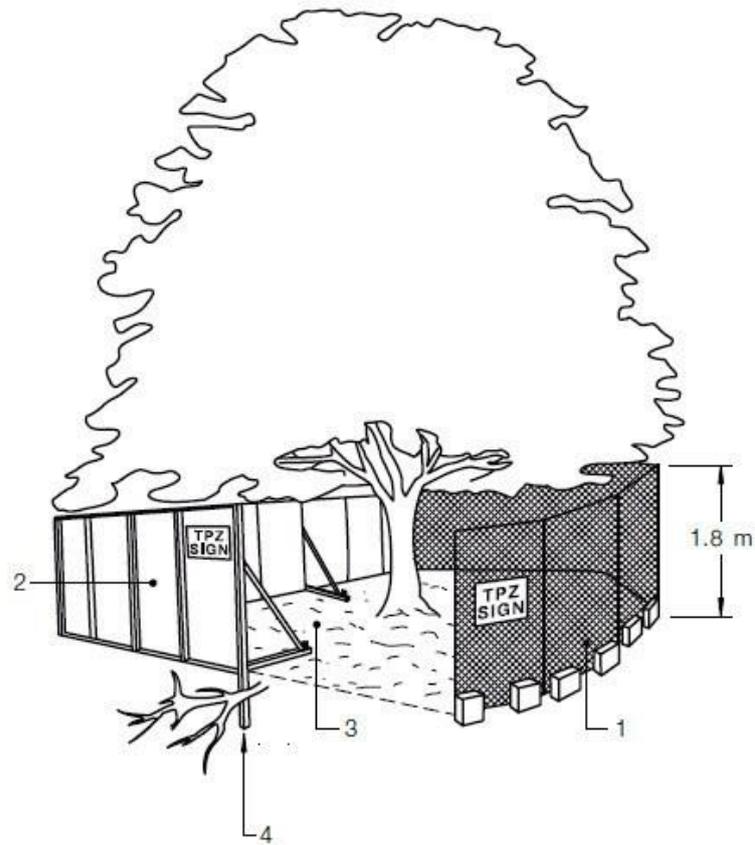
**Figure 1: Example of protective fencing**

- 1 Chain wire mesh panels with shade cloth (if required) attached, held in place with concrete feet.
- 2 Alternative plywood or wooden paling fence panels. This fencing material also prevents building materials or soil entering the TPZ.
- 3 Mulch installation across surface of TPZ (at the discretion of the project arborist). No excavation, construction activity, grade changes, surface treatment or storage of materials of any kind is permitted within the TPZ.
- 4 Bracing is permissible within the TPZ. Installation of supports should avoid damaging roots.

Fencing should be erected before any machinery or materials are brought onto the site and before the commencement of works including demolition. Once erected, protective fencing must not be removed or altered without approval by the project arborist. The TPZ should be secured to restrict access.

AS 4687-2007 (Temporary fencing and hoardings) specifies applicable fencing requirements. Shade cloth or similar should be attached to reduce the transport of dust, other particulate matter and liquids into the protected area.

Fence posts and supports should have a diameter greater than 20 mm and be located clear of roots.

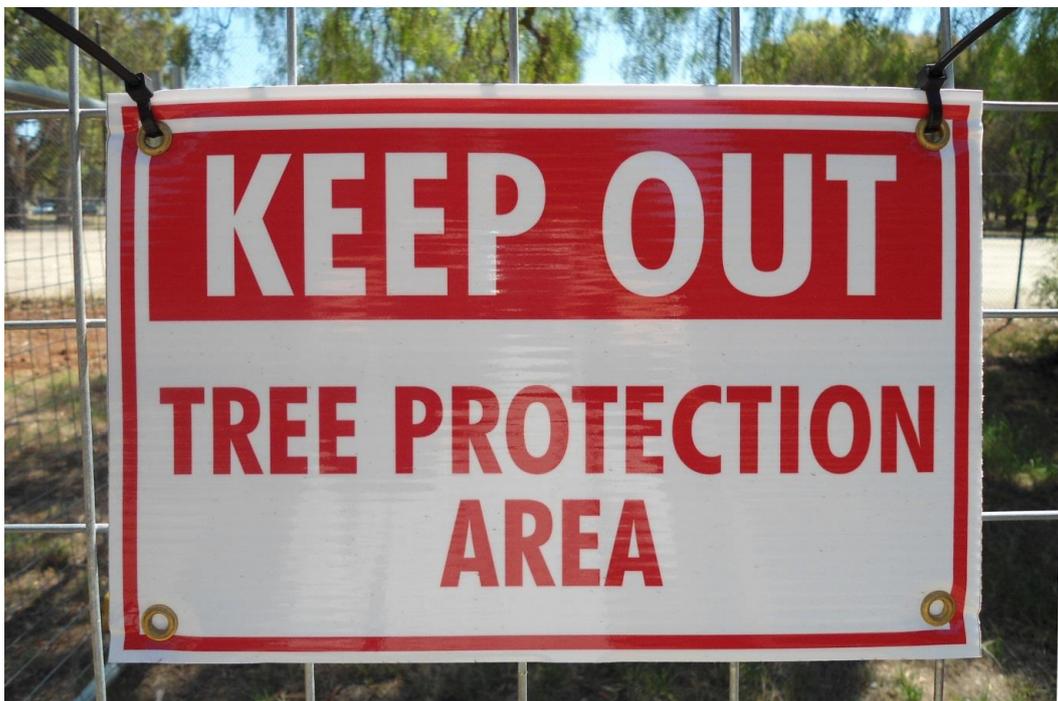
Figure 3: Example of TPZ signage

Signs identifying the TPZ should be placed around the edge of the TPZ and be visible from within the development site. The lettering on the sign should comply with AS 1319-1994 (Safety signs for the occupational environment).

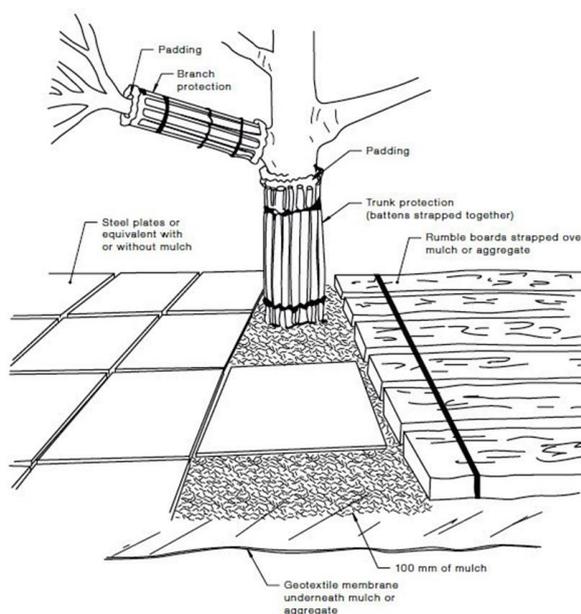
Figure 4: Examples of trunk, branch and ground protection.

Where necessary, install protection to the trunk and branches of trees as shown on Figure 4.

The materials and positioning of protection are to be specified by the project arborist. A minimum height of 2 m is recommended.

- If temporary access for machinery is required within the TPZ ground protection measures will be required. The purpose of ground protection is to prevent root damage and soil compaction within the TPZ. Measures may include a permeable membrane such as geotextile fabric beneath a layer of mulch or crushed rock below rumble boards as illustrated in Figure 4.
- These measures may be applied to root zones beyond the TPZ.

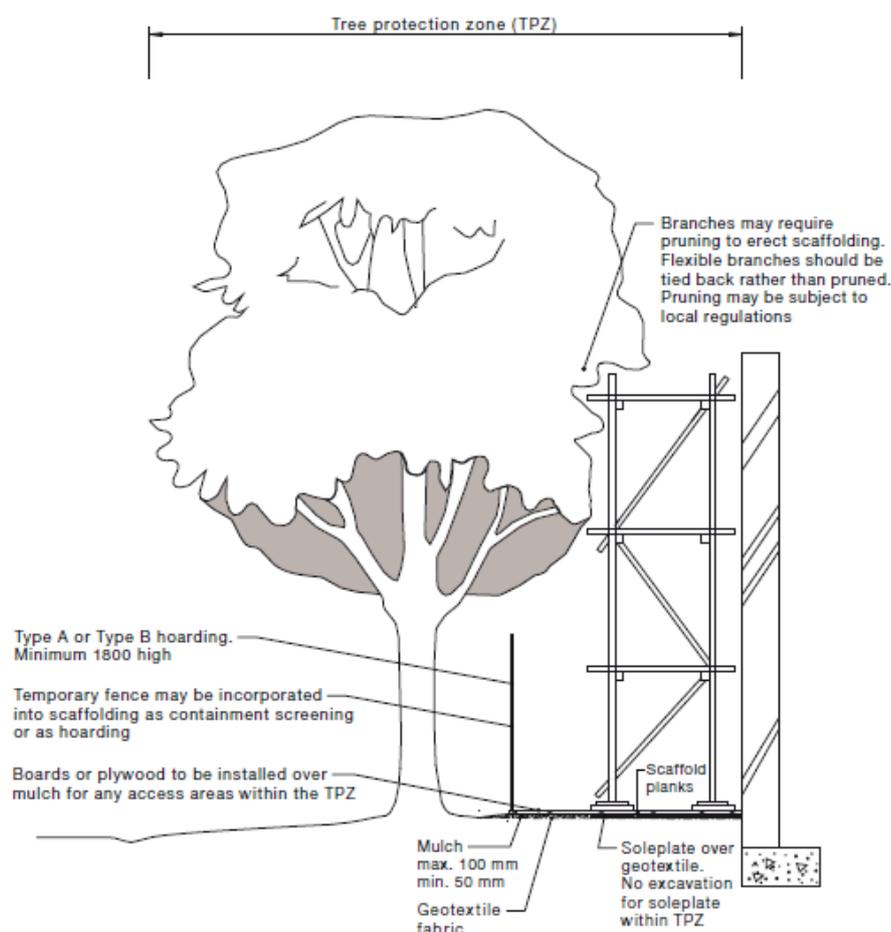
**Figure 5: Indicative scaffolding within a TPZ**

The ground below the scaffolding should be protected by boarding (e.g. scaffold board or plywood sheeting) as shown in Figure 5. Where access is required, a board walk or other surface material should be installed to minimize soil compaction. Boarding should be placed over a layer of mulch and impervious sheeting to prevent soil contamination. The boarding should be left in place until the scaffolding is removed.

NOTE: Excavation required for the insertion of support posts for tree protection fencing should not involve the severance of any roots greater than 20 mm in diameter, without the prior approval of the project arborist.
